Manhole Inspection Summary

Manhole # S07KK1013MH

Insp Date: **1/20/09 2:32 PM**

Location Address: **LITCHFIELD AVE**

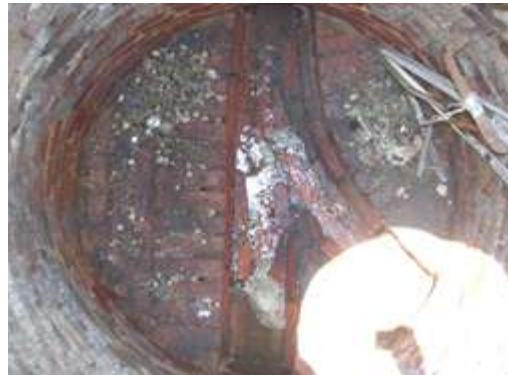
Top View

DEBRIS ON BENCH

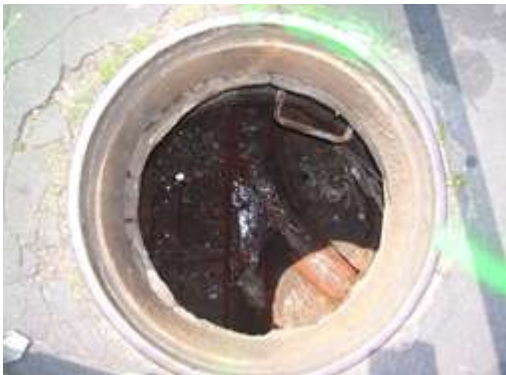
Top View

Offset: **1** (in.)

FRAME OFFSET

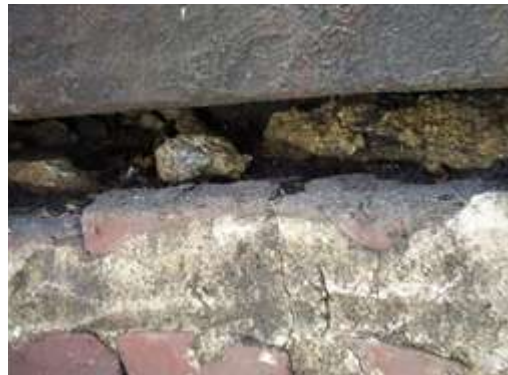
Defect 2

Condition: ☐ Sound ☐ Cracked ☐ Root Intrusion ☐ Loose Brick ☒ **Deteriorated**

FRAME ADJUSTMENT
DETERIORATED.

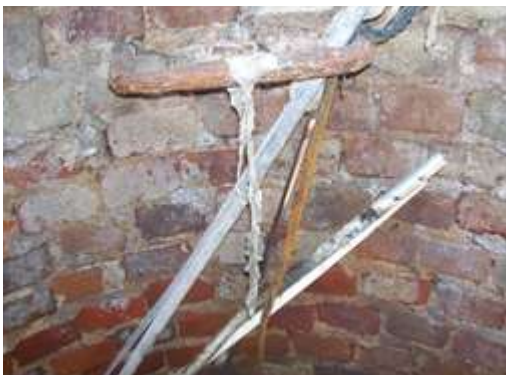
Defect 1

☒ **Evidence Of Surcharge** Depth: **4** (ft.) ☐ Active Surcharge Present

EVIDENCE OF SURCHARGE

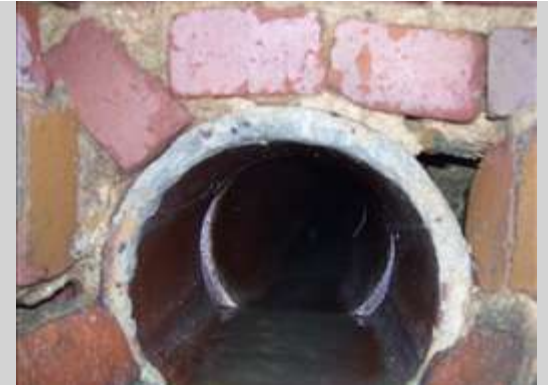
12 O'Clock Outflow

Pipe Height: (in.) Direct
Pipe Material: **Clay** ☐ Pipe Lined
Invert Depth: **6.68** (ft.) Flow Characteristics: **Slow**
Deposits: ☒ None ☐ Mud ☐ Sludge ☐ Debris ☐ Grease
Silt Depth: (in.) Deposits Extent:
Infiltration: **None** Pipe Seal Cond: **Broken**
